# Experimental investigation on the behaviour of patched reinforced concrete column under eccentric loading: a case of compression failure

Manohar <sup>1</sup>Arjun Reddy <sup>2</sup>Prashanth Kumar <sup>3</sup>

Department of Civil Engineering, Kakatiya University Warangal

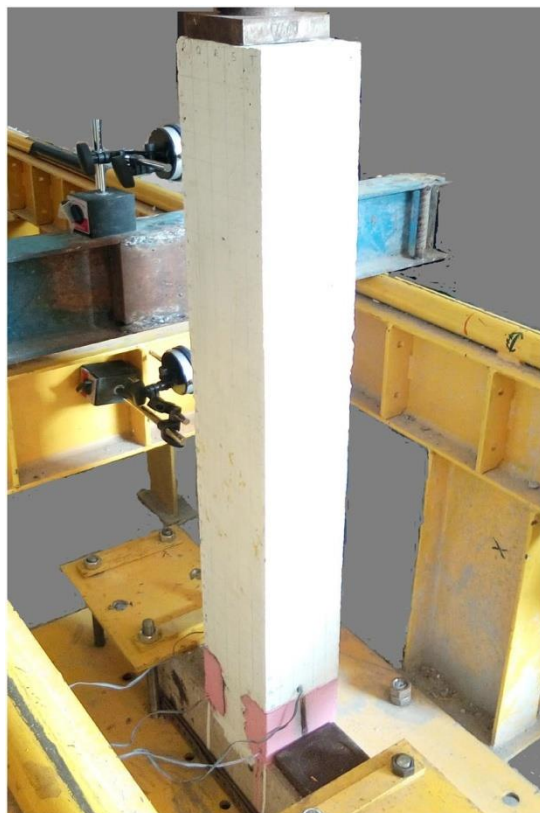
**Fig. 2** Fitting the RC column specimen to restrain translation and rotational movement at the beam-column joint

As the horizontal beam at the base of the RC column sits on top of the base plate, the column was positioned on top of it. Several anchors were used to secure the base plate to the hard floor. The horizontal beam was topped with upper steel plates on each side of the vertical column. Using the matching nuts and four threaded bars, each plate was fastened to the base plate. Tightening the nuts would stop the RC column specimen from moving in any direction, including translation and rotation. This would lead one to believe that the RC column is immobile at its bottom joint (i.e., not capable of translation or rotation) and completely free at its top joint (i.e., capable of both). Utilising a loading jack, the column was subjected to axial loading. The loading jack was connected to the top of the column by inserting a loadcell. The magnitude of the applied load was measured by this loadcell. An eccentric application of the axial load was made. The axial load that was applied had an eccentricity of 10 mm. This irregularity caused the RC column to be subjected to both axial and flexural loads. It was anticipated that the RC column would burst by a compression failure mechanism at this eccentricity of 10 mm. The specimen was subjected to loading increments of 100 kg until it reached the final value that ruptured it. Dial gauges were used to monitor lateral deformations while strain gauges were used to measure axial deformations at each load increment. Near the junction, strain gauges are fastened to the surface of the concrete or UPR mortar.

at the ends of the fibres. The surface of the longitudinal reinforcements was also equipped with strain gauges (see to Fig. 1a-d for details). Fig. 2 shows that dial gauges are used to measure the columns' lateral displacement at 500 mm (lower level) and 800 mm (higher level).
